1. Update from Town staff re: Building Bridge 2 (632-636 San Anselmo Avenue)

We have completed our limited investigation of the existing concrete bridge and walls known as Building Bridge 2 (BB2) in San Anselmo, CA. This letter describes our Observations, Conclusions and Recommendations, and was prepared at your request under the scope of SAFRR Task Order #2 between Martin/Martin Consulting Engineers and the County of Marin. The investigation included visual observation of the BB2 structure and is based on conditions that were readily observable at the time of our site visit. In accordance with Task Order #2, existing drawings were not provided for review (we understand they are not available), no invasive demo or testing was performed, and no structural analysis calculations were completed.

San Anselmo Creek Building Bridge 2 (BB2) Structural Evaluation September 12, 2022

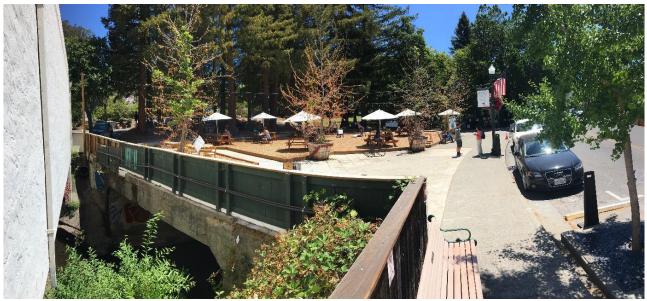
The Building Bridge 2 (BB2) structure spans across the east and west sides of the San Anselmo Creek, in San Anselmo's commercial downtown district. As seen in the **Image 1** below, taken from the Northwest corner of BB2, the bridge deck is currently used as a public plaza, and has been covered with hardscaping and light landscaping.

Image 1: BB2 and Plaza from San Anselmo Ave

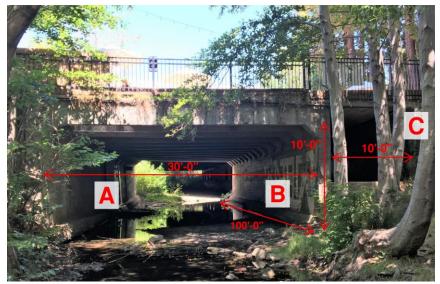
- 1. Deck: 6" Concrete deck spanning 7'-0" between concrete beams
- 2. Beams: 30" deep x 14" wide concrete beams spanning 30'-0" between walls across the creek
- 3. Right Bank Wall (A): 10'-0" tall concrete retaining wall
- 4. Left Bank Bridge Wall (B): 10'-0" tall x 10" thick concrete wall with pilasters
- 5. Left Bank Retaining Wall (C): 8'-0" tall x 10" thick concrete retaining wall
- 6. Tie Beams: 18" deep x 15" wide concrete tie beams at the base of Wall B & Wall C
- 7. Foundations: Wall foundations of unknown size

Image 2A: Upstream (South Elevation) View of BB2

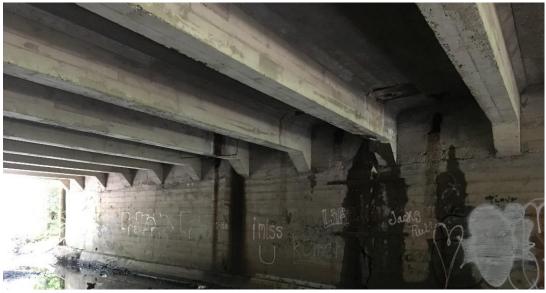
- The concrete deck appears to consist of a 6" one-way concrete slab, spanning between beams. It is assumed to be reinforced with steel rebar. See **Image 3** below.
- The deck was only available to view from the underside, and no obvious signs of deterioration, significant cracking, or excess deflection were apparent from our limited visual observation.
- The concrete beams are 14" wide, 24" deep below the slab (30" total), and span 30'-0". They are reinforced with steel rebar, and rebar was exposed at (at least) one location as shown in the top right corner of **Image 4** below.
- The concrete beams showed some minor signs of deterioration and spalling, especially at the bottom face of the beam.

Image 3: Slab & Beams Looking West at the Right Bank Wall

- 1. If the BB2 structure is going to be repurposed in the future, and reused in the long-term, a structural engineer should be engaged to observe the concrete deck from the top to determine if there are any obvious signs of deterioration that were unavailable to view during our limited inspection.

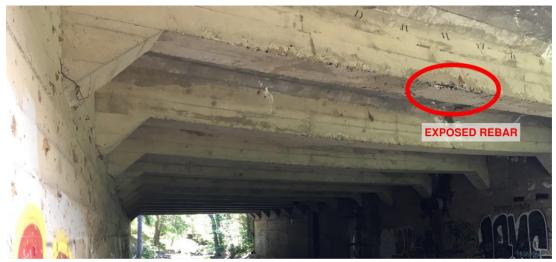
Image 4: Beam Deterioration at Bottom Face and Expose Rebar

- 2. If the BB2 structure is going to remain in use long-term, the existing beams should be evaluated in more detail. Mid-span deflection measurements should be taken to determine if there is excessive deflection potentially caused by long-term creep. Repair recommendations should be provided to mitigate the risk of rebar deterioration where rebar is currently exposed. The repair would likely involve the use of a repair mortar to protect the exposed rebar and strengthening with a fiber reinforced polymer (FRP) solution.

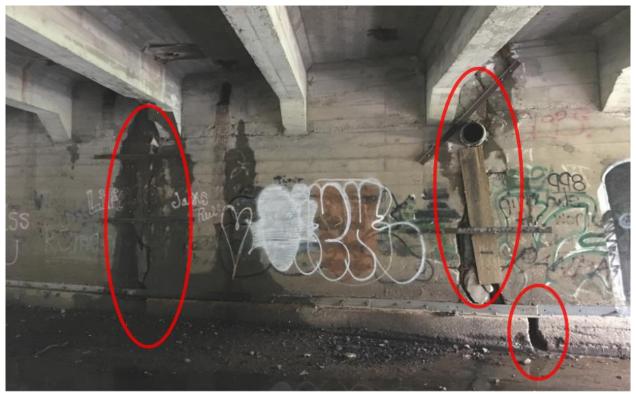
- Significant damage to the existing wall was observed at two locations, near the middle third of the wall height, as shown in **Image 5** below. Both cracks are sources of water passage through the wall, and the larger crack on the right in Image 5 below is located at a drainpipe. The wall separation is larger at the bottom than the top, and the size of the crack/ separation in wall is a few inches at the left crack, and around one foot at the right crack. Both cracks extend through the foundations.

- The foundations are sloped towards the middle of the wall, such that it appears the middle of the wall has sunk relative to the North and South ends of the wall. This suggest the wall is not on deep foundations.

- Steel angles were observed anchored to the existing concrete across the cracks and foundation. They appear to have been installed in attempt to limit further wall and foundation separation. The angles look like they have been in place for several years, indicating that this is not a recent wall failure.

Image 5: Large Cracks in Right Bank Wall and Foundation

- The Right Bank Wall and foundation has experienced significant cracking and concrete separation at two specific locations. Further structural evaluation would be required to determine the cause of this damage, but there are two likely possible explanations for the observed behavior:

- The cracks may be an indication of an in-plane flexural failure of the wall and foundation. This would create tension at the bottom of the wall (where cracks are larger) and compression at the top of the wall, matching the pattern of the cracks and damage. It's possible the excessive in-place flexural demand was caused by a failure of the foundations in the middle of the wall. It's possible that years of erosion of the creek bed has undermined and deteriorated the foundations, creating a gap in adequate and continuous vertical soil support.

- 2. The cracks may have been caused by a buildup of hydrostatic pressure behind the wall due to poor drainage and/or concentrated water discharge (such as drainpipes). Damage would have then been caused by water intrusion deteriorating the concrete and rebar overtime.

- 1. If the BB2 structure is going to have a long-term use with public accessibility, prior to determining the extent of repairs, further structural evaluation should be performed to determine:
 - A. The extent of damage along the soil-side of the wall caused by excessive flexure, similar to the Left Bank Bridge Wall.
 - B. Whether the wall has experience excessive rotation or lateral displacement, which may have induced damage at the Left Bank Bridge Wall.
 - C. The extent of erosion and damage to the foundations to determine if that are still adequate to support the wall for future use. This would likely require exploratory pits dug at multiple locations.
- 2. Repair recommendations should be made after further evaluation is completed. Repairs may include new horizontal support for the wall in the form of tiebacks or foundation replacement.

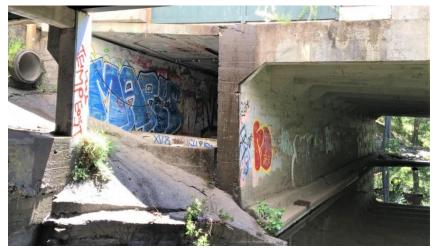
- The Left Bank Bridge Wall is a concrete wall supporting the East end of the bridge deck that also retains soil to approximate mid-height. This wall was observed from all sides. It consists of a 10" thick concrete wall with 14"x16" concrete pilasters at approximately 7'-0" on-center aligned with the bridge beams supporting the main bridge span. Image 6 below shows the wall from the North side of the bridge, looking South. Image 2 above shows the wall from the South side of the bridge, looking North.
- There is a tunnel between the Left Bank Bridge Wall and the Left Bank Retaining Wall, as shown in **Image 7** below, with 15"x18" concrete tie beams connecting the two as shown in the Images.

Image 6: Left Bank Bridge Wall looking South

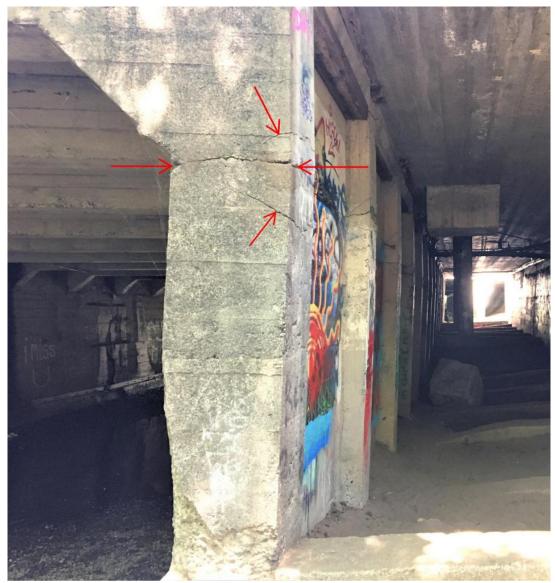
- There is obvious damage to the Left Bank Bridge Wall, including cracks through the full wall and pilaster. Where the base of the bridge beam haunch meets the concrete pilasters, the backside of the pilasters and wall are cracked, and concrete has separated. There is a clear hinge in the wall and pilasters at this location, and the pilasters bow outward at this point. Additionally, the top of the wall has displaced laterally to the East. The location of these cracks is shown in **Image 8**.

Image 8: Southern-most Pilaster looking North

- The hinge formation in the concrete wall and pilasters is caused by an excessive flexural demand at the top of the pilaster. The flexural demand has caused the East face of the pilasters to experience excessive tensile strain in the concrete and rebar, causing the concrete to crack and spall, and the integrity of the concrete to deteriorate.

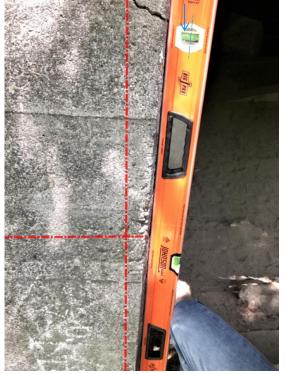
Image 10: Southern-most Pilaster w/ Level

• In **Images 10 & 11** below, a red vertical line drawn over the vertical laser level line shows the typical horizontal displacement pattern of the pilasters. A four-foot level placed up against the backside of the pilasters was used to verify the laser level line was vertically plumb, and that the pilaster was out-of-plumb.

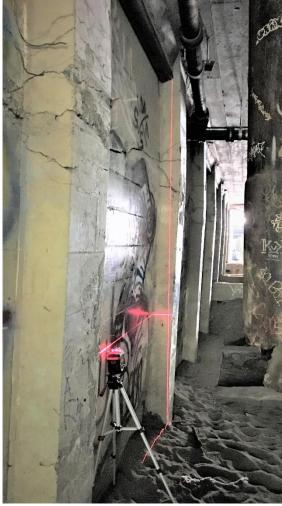
- Horizontal displacement measurements were taken, using the self-leveling laser, at what appeared to be the worst-case interior pilaster, as shown in **Images 12 and 13** below.
- At the hinge point in the pilaster where the majority of the cracking occurs, the horizontal displacement relative to a vertical plumb line was measured to be between 3 and 4 inches. The amount of displacement and cracking appeared to be generally consistent at each pilaster, with a few exceptions where there was more concrete spalling.
- At the top of the pilaster and wall, the horizontal displacement relative to a vertical plumb line was measured to be between 2 and 3 inches. This indicates that the top of the wall appears to have displaced laterally to the East.

Image 12: Self-leveling Laser at Interior Pilaster

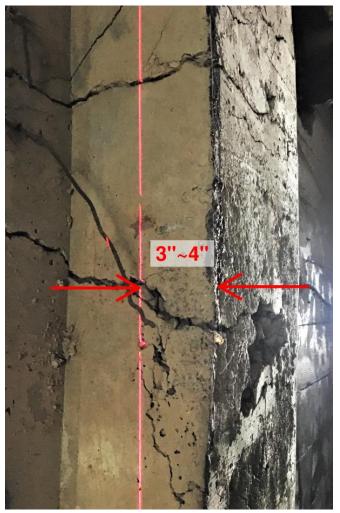
Image 13: Interior Pilaster Deflection at Crack

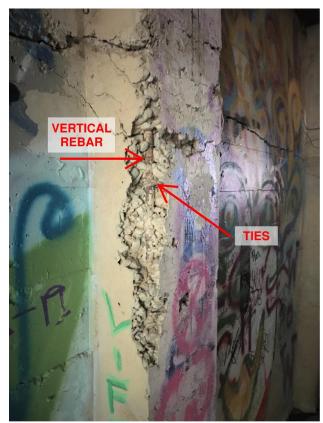
- At a few pilaster locations, concrete cracking was significant enough that it exposed rebar in the pilasters. The worst-case condition is documented in **Images 14 and 15** below. At this location there is evidence of pour concrete consolidation during the original construction.
- At this pilaster location, three vertical #5 or #6 deformed steel reinforcing bars were visible at the backside face of the pilaster. Small pilaster ties were observed at roughly 12" on-center. The exposed rebar showed signs of rust and deterioration.
- The aggregate exposed at this location appeared to be smooth rock varying in size from $\frac{1}{2}$ " to 1".

Image 14: Exposed Rebar at Pilaster

- Since no original drawings are available, the level of structural deficiency is unknown.
- The cracks and spalling have exposed the pilaster rebar to rust and deterioration, the extent of which is unknown and would require further study. Rebar deterioration reduces the available flexural strength in the pilasters.

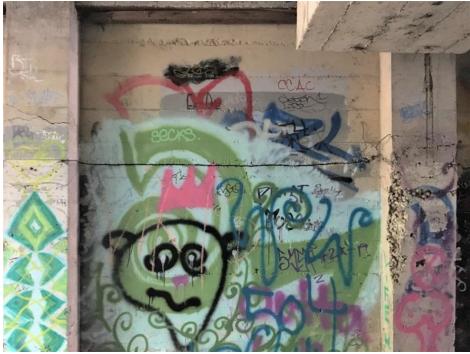
• A very clear and consistent horizontal crack along the backside of the wall between pilasters was observed along the full length of the wall. The crack was located at the bottom of the bridge beam haunch, at the top of the hinge in the concrete pilasters. This crack is shown in **Images 16 and 17** below.

Image 16: Left Bank Bridge Wall Horizontal Crack

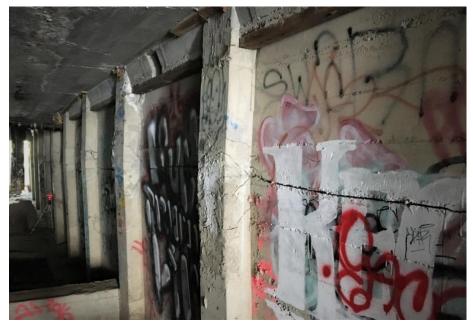
Image 17: Left Bank Bridge Wall looking South

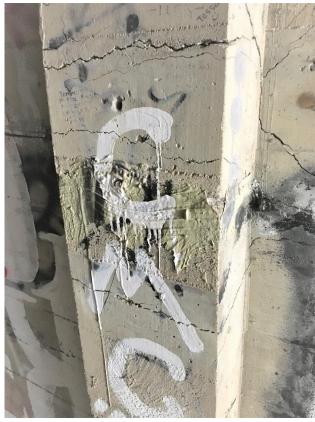
- At a few pilaster locations, it was observed that there had been previous attempts at filling the cracks by injecting them with an injection repair product. At some locations, the cracks appeared to still be filled. At most locations, the cracks appear to have re-opened indicating that the cause of the distress was not addressed by prior repair procedures. The date of the previous repairs was not known.
- **Image 18** shows a typical crack injection location where the crack remained covered by the repair product.
- Image 19 shows a typical crack injection location where the crack had opened-up since the repair attempt, in this case by approximately 1/8". An abandoned nozzle tip from the cracking injection operation is still visible.

Image 18: Signs of Previous Crack Repair

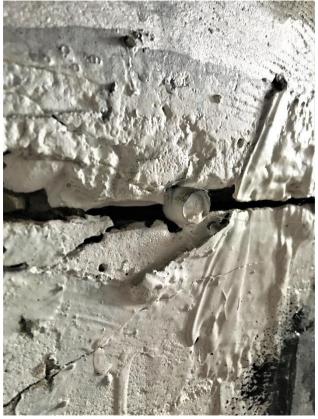
Image 19: Failed Crack Injection

- The flexure and resulting rotational deformation in the pilasters appear to be an ongoing issue that has worsened over time. This conclusion is based on the observation that previous crack repairs appear to have failed and cracks re-opened.

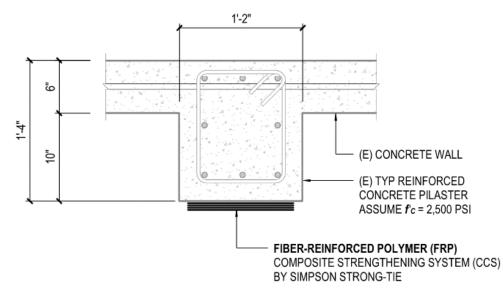
Image 25: Schematic of FRP Reinforcing at Pilasters

Option 2 – FRP Column Strengthening: A Fiber-Reinforced Polymer (FRP) wrap should be installed on the East face of each existing concrete pilaster (15 locations). The FRP should be installed by a competent and experienced FRP installer. The FRP designer should provide the maximum amount of FRP flexural strengthening that is practical for this application. See Image 25 below.

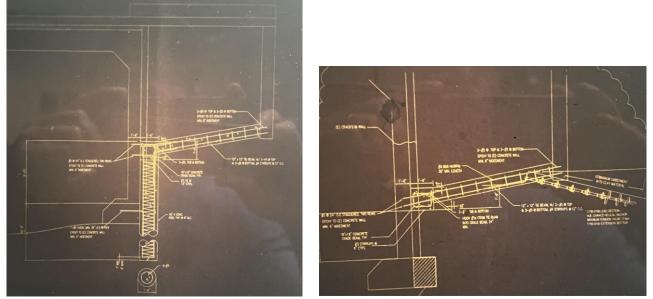
Image 1: Permit Drawings from 2002 Foundation Repair

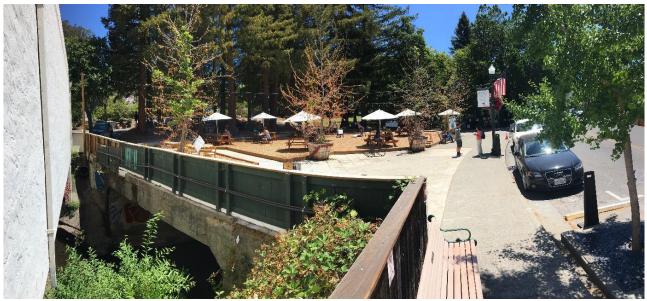
The Building Bridge 2 (BB2) structure spans across the east and west sides of the San Anselmo Creek, in San Anselmo's commercial downtown district. As seen in the **Image 2** below, taken from the Northwest corner of BB2, the bridge deck is currently used as a public plaza, and has been covered with hardscaping and light landscaping.

Image 2: BB2 and Plaza from San Anselmo Ave

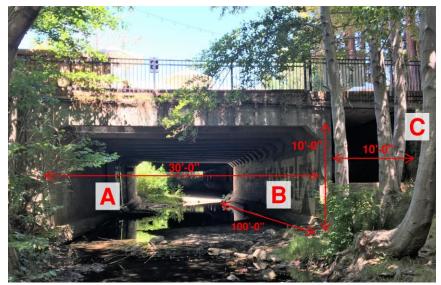
- 1. Deck: 6" Concrete deck spanning 7'-0" between concrete beams
- 2. Beams: 30" deep x 14" wide concrete beams spanning 30'-0" between walls across the creek
- 3. Right Bank Wall (A): 10'-0" tall concrete retaining wall
- 4. Left Bank Bridge Wall (B): 10'-0" tall x 10" thick concrete wall with pilasters
- 5. Left Bank Retaining Wall (C): 8'-0" tall x 10" thick concrete retaining wall
- 6. Tie Beams: 18" deep x 15" wide concrete tie beams at the base of Wall B & Wall C
- 7. Foundations: Wall foundations of unknown size

Image 3: Upstream (South Elevation) View of BB2

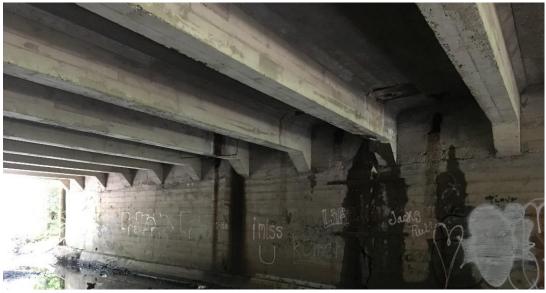
- The concrete deck appears to consist of a 6" one-way concrete slab, spanning between beams. It is assumed to be reinforced with steel rebar. See **Image 5** below.
- The deck was only available to view from the underside, and no obvious signs of deterioration, significant cracking, or excess deflection were apparent from our limited visual observation.
- The concrete beams are 14" wide, 24" deep below the slab (30" total), and span 30'-0". They are reinforced with steel rebar, and rebar was exposed at (at least) one location as shown in the top right corner of **Image 6** below.
- The concrete beams showed some minor signs of deterioration and spalling, especially at the bottom face of the beam.

Image 5: Slab & Beams Looking West at the Right Bank Wall

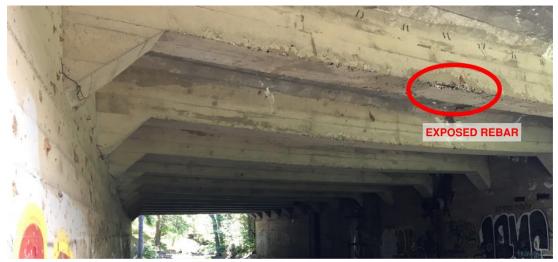
Image 6: Beam Deterioration at Bottom Face and Expose Rebar

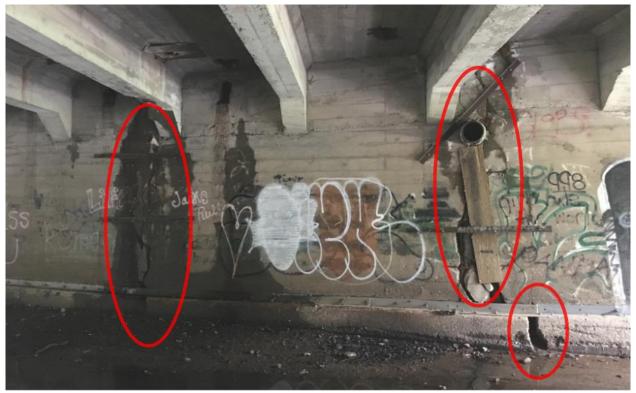
- Steel angles were observed anchored to the existing concrete across the cracks and foundation. They appear to have been installed in attempt to limit further wall and foundation separation. The angles look like they have been in place for several years, indicating that this is not a recent wall failure.

Image 7: Large Cracks in Right Bank Wall and Foundation

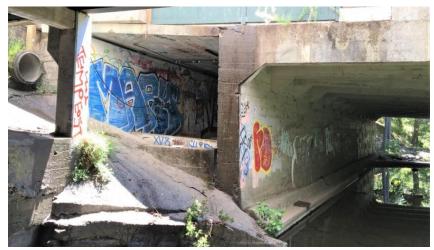
- The Left Bank Bridge Wall is a concrete wall supporting the East end of the bridge deck that also retains soil to approximate mid-height. This wall was observed from all sides. It consists of a 10" thick concrete wall with 14"x16" concrete pilasters at approximately 7'-0" on-center aligned with the bridge beams supporting the main bridge span. Image 8 below shows the wall from the North side of the bridge, looking South. Image 4 above shows the wall from the South side of the bridge, looking North.
- There is a tunnel between the Left Bank Bridge Wall and the Left Bank Retaining Wall, as shown in **Image 9** below, with 15"x18" concrete tie beams connecting the two as shown in the Images.

Image 8: Left Bank Bridge Wall looking South

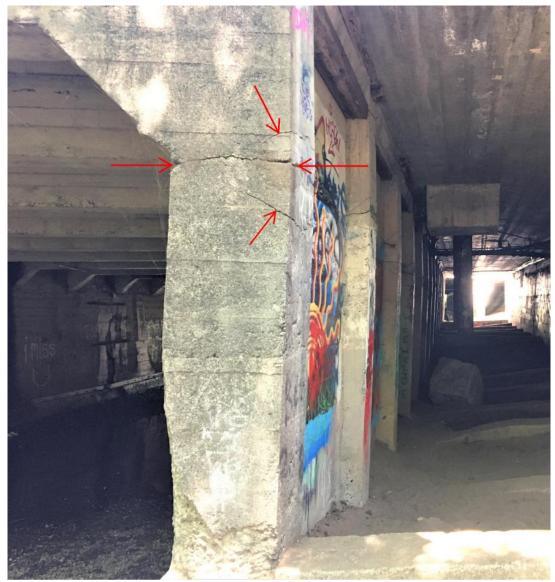
Image 10: Southern-most Pilaster looking North

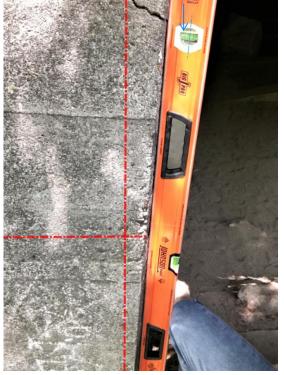
Image 12: Southern-most Pilaster w/ Level

• In **Images 11 & 12** below, a red vertical line drawn over the vertical laser level line shows the typical horizontal displacement pattern of the pilasters. A four-foot level placed up against the backside of the pilasters was used to verify the laser level line was vertically plumb, and that the pilaster was out-of-plumb.

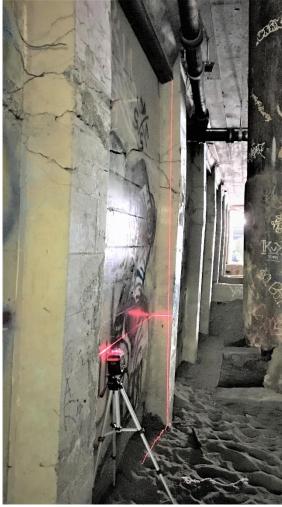
- Horizontal displacement measurements were taken, using the self-leveling laser, at what appeared to be the worst-case interior pilaster, as shown in **Images 14 and 15** below.
- At the hinge point in the pilaster where the majority of the cracking occurs, the horizontal displacement relative to a vertical plumb line was measured to be between 3 and 4 inches. The amount of displacement and cracking appeared to be generally consistent at each pilaster, with a few exceptions where there was more concrete spalling.
- At the top of the pilaster and wall, the horizontal displacement relative to a vertical plumb line was measured to be between 2 and 3 inches. This indicates that the top of the wall appears to have displaced laterally to the East.

Image 14: Self-leveling Laser at Interior Pilaster

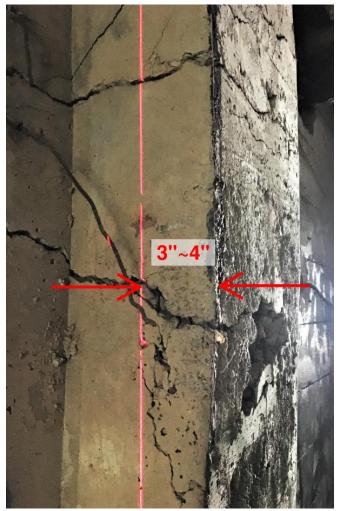
Image 15: Interior Pilaster Deflection at Crack

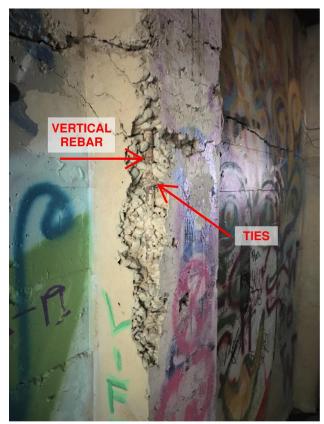
- At a few pilaster locations, concrete cracking was significant enough that it exposed rebar in the pilasters. The worst-case condition is documented in **Images 16 and 17** below. At this location there is evidence of pour concrete consolidation during the original construction.
- At this pilaster location, three vertical #5 or #6 deformed steel reinforcing bars were visible at the backside face of the pilaster. Small pilaster ties were observed at roughly 12" on-center. The exposed rebar showed signs of rust and deterioration.
- The aggregate exposed at this location appeared to be smooth rock varying in size from $\frac{1}{2}$ " to 1".

Image 16: Exposed Rebar at Pilaster

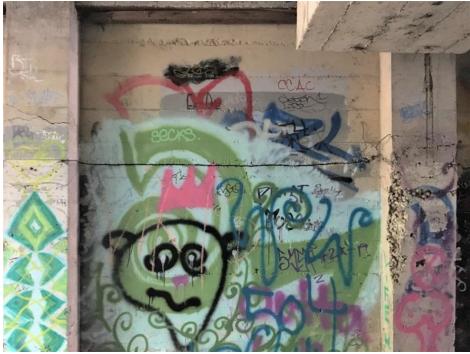
• A very clear and consistent horizontal crack along the backside of the wall between pilasters was observed along the full length of the wall. The crack was located at the bottom of the bridge beam haunch, at the top of the hinge in the concrete pilasters. This crack is shown in **Images 18 and 19** below.

Image 18: Left Bank Bridge Wall Horizontal Crack

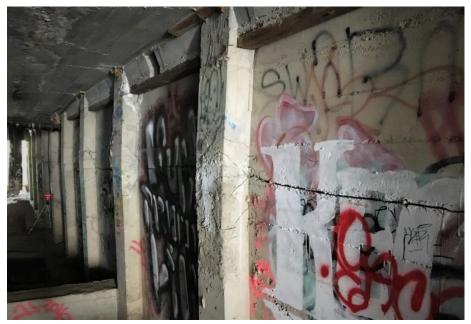
Image 19: Left Bank Bridge Wall looking South

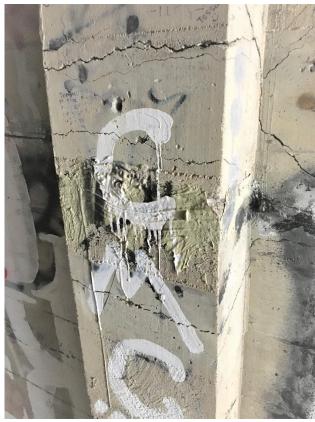
- At a few pilaster locations, it was observed that there had been previous attempts at filling the cracks by injecting them with an injection repair product. At some locations, the cracks appeared to still be filled. At most locations, the cracks appear to have re-opened indicating that the cause of the distress was not addressed by prior repair procedures. The date of the previous repairs was not known.
- Image 20 shows a typical crack injection location where the crack remained covered by the repair product.
- Image 21 shows a typical crack injection location where the crack had opened-up since the repair attempt, in this case by approximately 1/8". An abandoned nozzle tip from the cracking injection operation is still visible.

Image 20: Signs of Previous Crack Repair

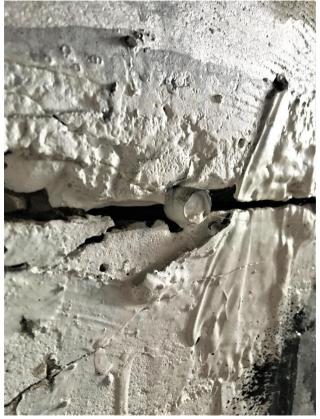
Image 21: Failed Crack Injection

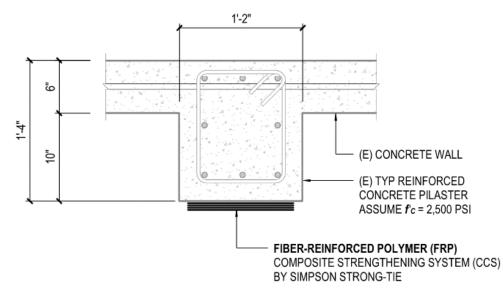
Image 27: Schematic of FRP Reinforcing at Pilasters

Option 2 – FRP Column Strengthening: A Fiber-Reinforced Polymer (FRP) wrap should be installed on the East face of each existing concrete pilaster (15 locations). The FRP should be installed by a competent and experienced FRP installer. The FRP designer should provide the maximum amount of FRP flexural strengthening that is practical for this application. See Image 27 below.

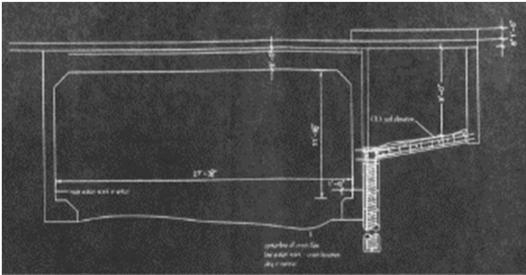
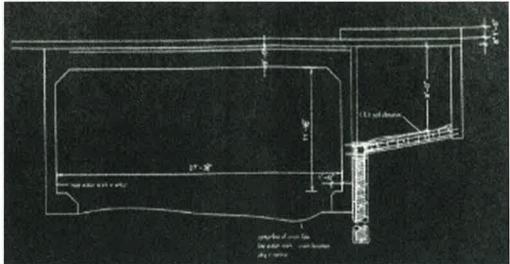
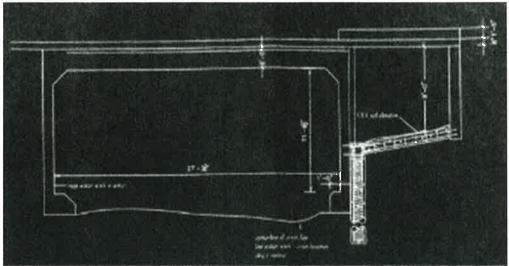
The project is a "building bridge" that was likely constructed post war (circa 1945-1950) as evidenced by the board-formed concrete and round rebar discovered on site. The bridge type is a single span Tgirder slab bridge sitting atop concrete pilasters and shallow spread foundations that spans (27'3") over San Anselmo Creek. The pilasters have in-fill walls that help with transverse shear capacity of the structure.

Building Bridge #2 – Plans by Ballard and Watkins

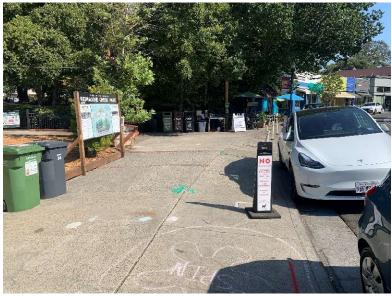
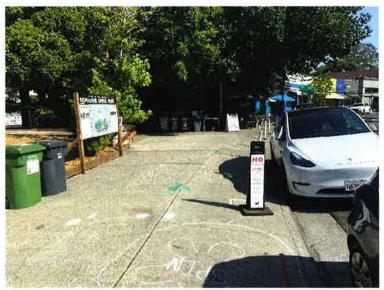
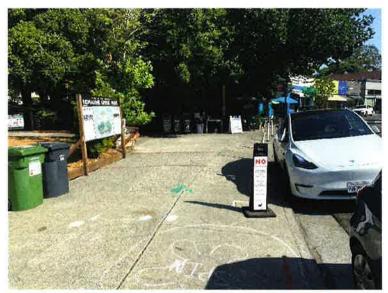
Based on the structural observations conducted on the September 9th and 10th, the bridge historically underwent significant scour events that caused the footings on the Northeast Abutment to be scoured and undermined. This could have occurred over an extended period of successive floods or a single event that impacted the bridge but were not documented as part of this Assessment. There is evidence of some settlement behind the Southeast Abutment on the sidewalk of San Anselmo Avenue.

Minor Settlement of Sidewalk over Southeastern Abutment

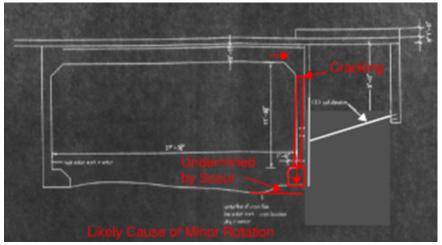
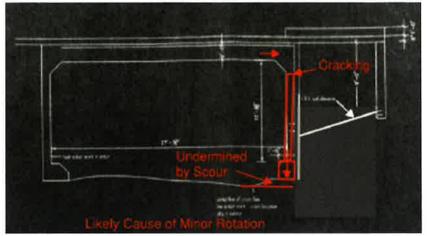
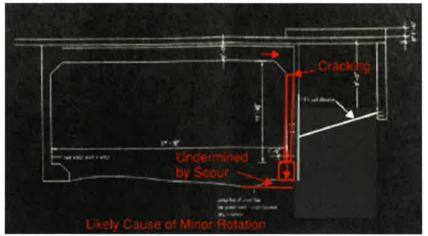
What is observed and deduced in this report is that the Northeast Abutment appears to have rotated and the structure has slightly racked laterally to the Northeast. Because the bridge was previously locked from movement and had substantial reinforcement in the pilasters (6-#6 Bars) and knee braces, the structure did not collapse; it appears to have simply rotated to a new point of equilibrium. It should be prudent to note that the columns did not undergo full plastic hinging as the reinforcement does not appear to have lost section and confinement reinforcement is still intact. It appears that only the cover has cracked and spalled.

Scour event that caused minor rotation

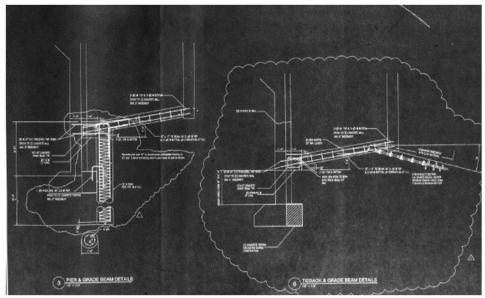
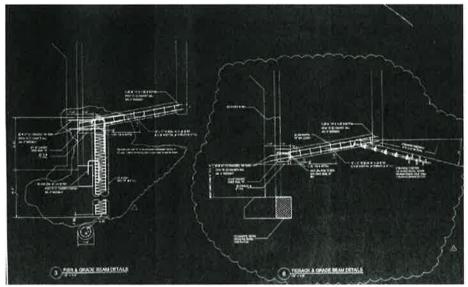
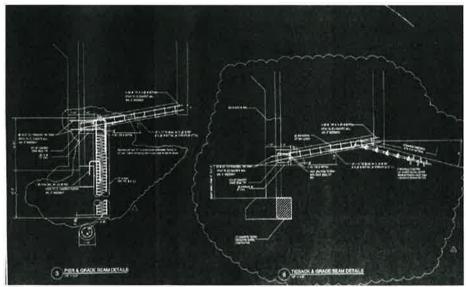
The racking did, however, cause tension on the back side of the knee brace/pilaster and caused some cracking. The repair strategy used by Ballard and Watkins revolved around the idea of underpinning the footings with doweled-in piers extending into stiff clay or bedrock at 8'0" o.c. In addition, a continuous grade beam with helical piers was used to help restrain the Pilasters from future racking. This also serves be restraining the columns and footings from kicking out towards the creek.

Underpinning and Tiebeams with Helical Piers Repair by Ballard and Watkins

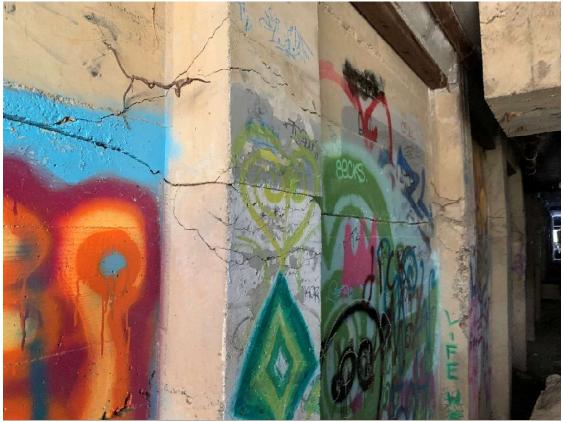
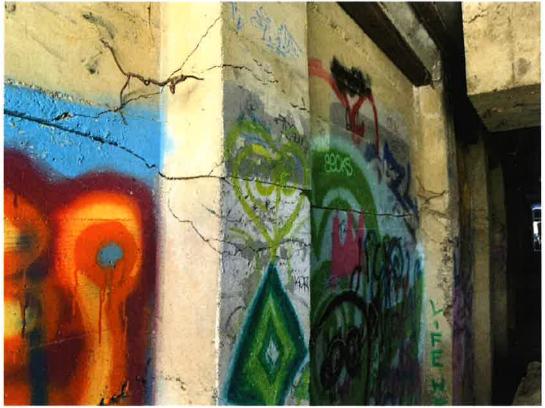
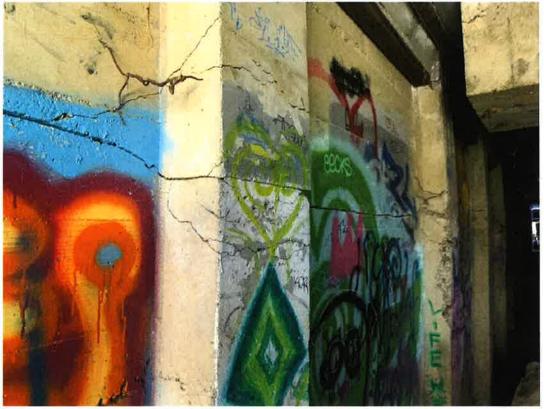
Also noted in my site visits, it is evident that the columns/pilasters have cracked as a result of the scour event(s). This is partial plastic hinging as the columns deflected a few degrees out of plumb. However, reduced structural capacity does appear to have taken place and the structure is sufficient to support applied gravity loads (DL+LL) Fortunately, this cracking does not show signs of severe effect into the core of the column. This suggests there is sufficient capacity to support the nominal pedestrian loading that it currently undergoes.

Cracking due to tension on the back face of the Pilasters/Columns

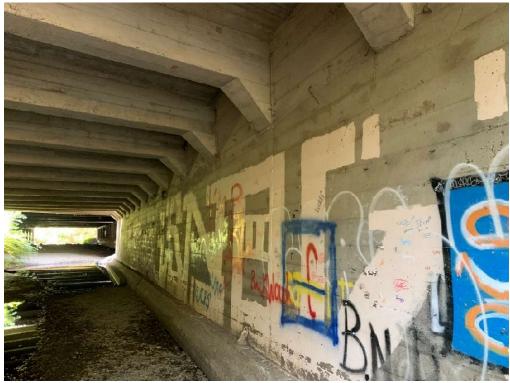
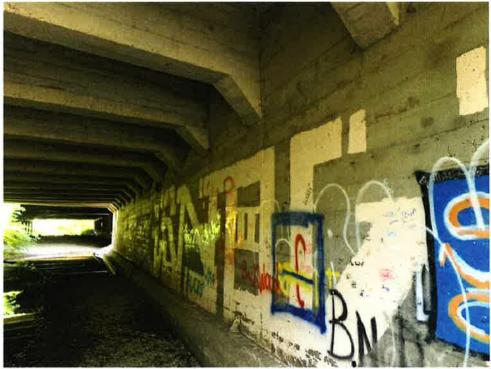
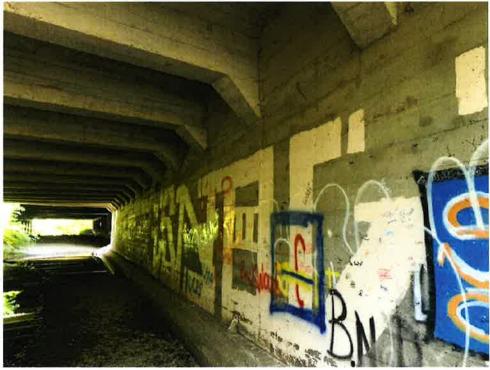
What strengthens my assessment that the structural still has substantial capacity against collapse is the inside face of the Northeastern pilaster/knee braces appear to be in excellent condition with virtually no evidence of cracking.

Inside face of structure is near original condition and structurally sound.

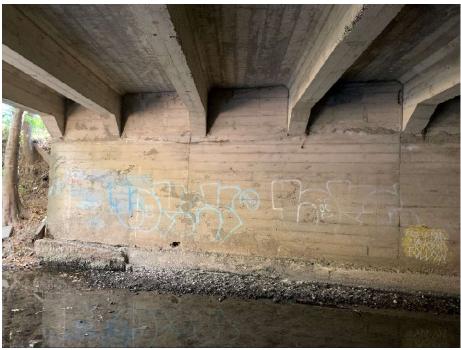
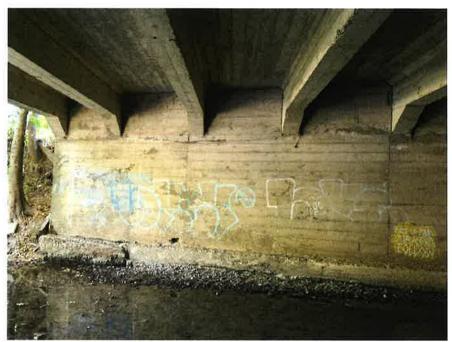
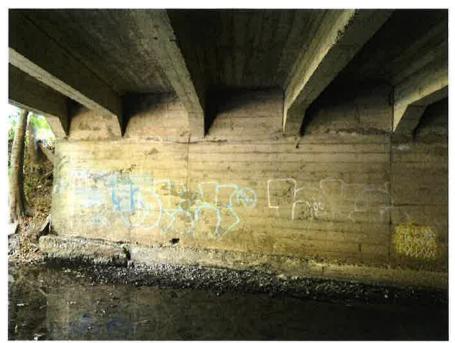
Moreover, since the bridge is braced against lateral movement with soil and tie beams with helical piers and underpinned with drilled piers, the probability for a catastrophic failure is low based on known conditions.

The bridge deck and girders appear to be in good condition.

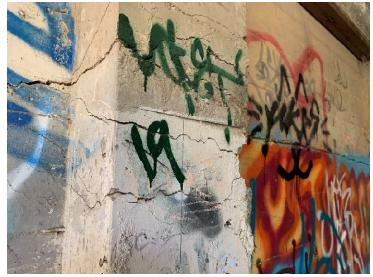
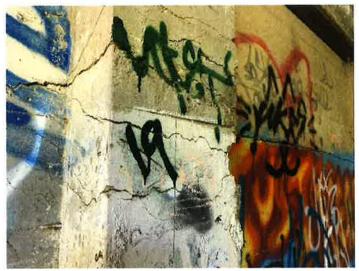
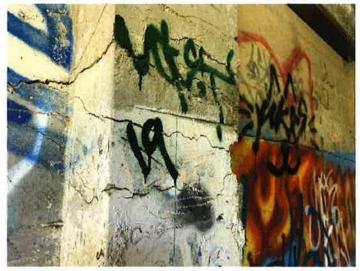
1) **Type 1 (Surficial Defects)** that are 0.25 to 2" cracks and honeycombing in the cover.

Type 1 Defect

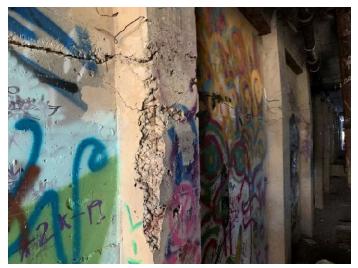
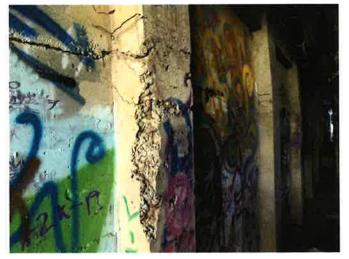
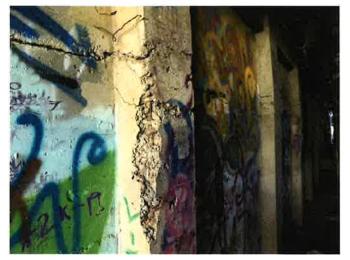
2) **Type 2 (Minor Defects)** that are 1.5 to 3" cracks and honeycombing in the cover and minor entry into the core area.

Type 2 Defect

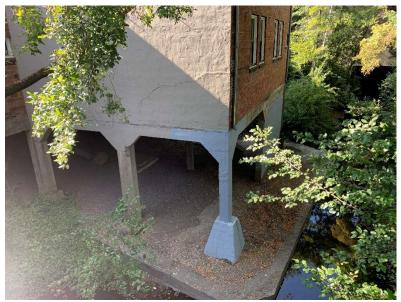
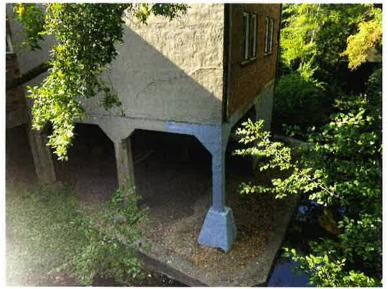
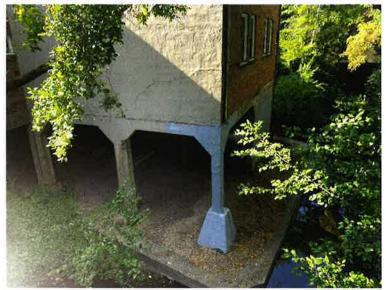
Example FRP beam/column repair at 526 San Anselmo Ave

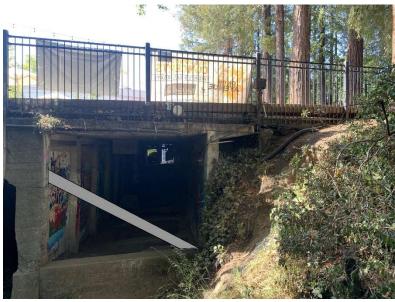
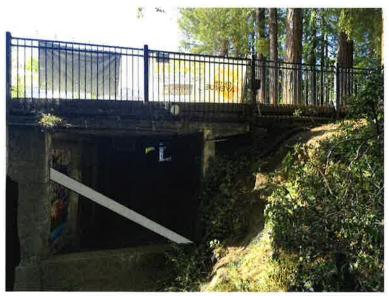
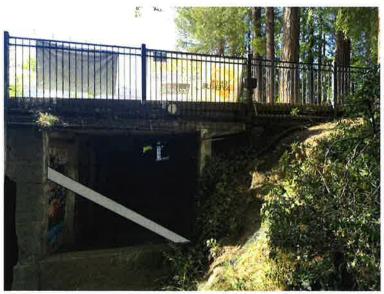
HSS Brace to Restrain Knee-Brace and prevent racking
